ANALYSIS OF ROAD DAMAGE USING THE SURFACE DISTRESS INDEX (SDI) METHOD ON THE GRESIK-SURABAYA ROAD SECTION KM. 4+900 TO KM. 7+700

Judiono

University of Sunan Giri Surabaya

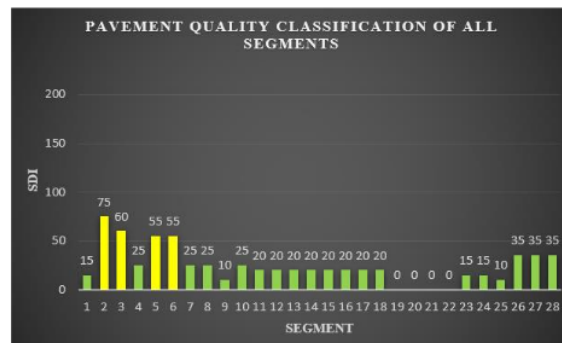
Figure 4. SDI Value Graph of the entire Segment

Based on the graph of the SDI value of the entire segment, it can be seen that the level of damage that gets a medium SDI value is in segment 2, where the segment gets an SDI value of 75, while the lowest value is in segments 19 to 22, which gets an SDI value of 0, where in the segment there is no damage and the pavement in the segment is in good condition. The average SDI value on the Gresik-Surabaya road section, Km 4 + 900 to Km 7 + 700, is a road in good condition that only requires repair and maintenance on several segments.

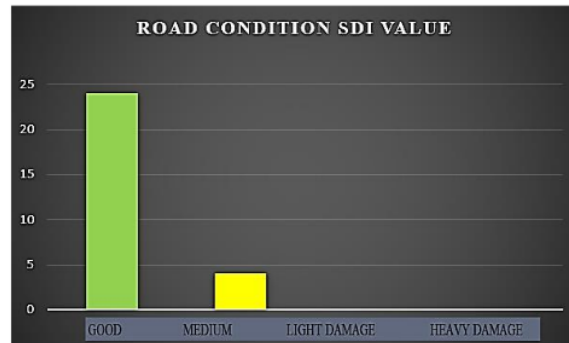
Figure 5. Graph of Road Condition Value

Based on Figure 6, The Road Condition Value Graph shows that of the 28 segments on the Gresik-Surabaya road section, 24 segments get a good value and 4 segments get a moderate road condition value, namely in segments 2, 3, 5, and 6, where at that location there is quite a lot of crack damage.
